Manhole Inspection Summary

Manhole # S25K__015MH

Location Address: **300 McHenry St**

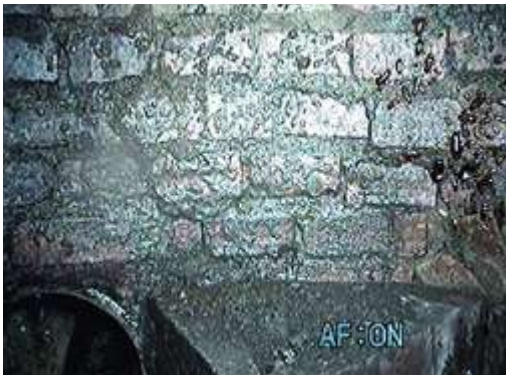
Defect 3

Bench Debris & Active infiltration on barrel wall

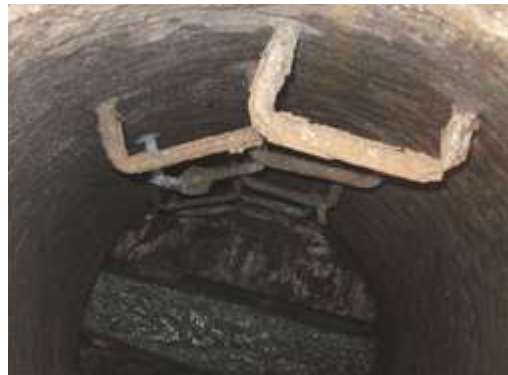
Defect 2

Count: **10** Missing: **4** ☒ **Corroded**

corroded steps

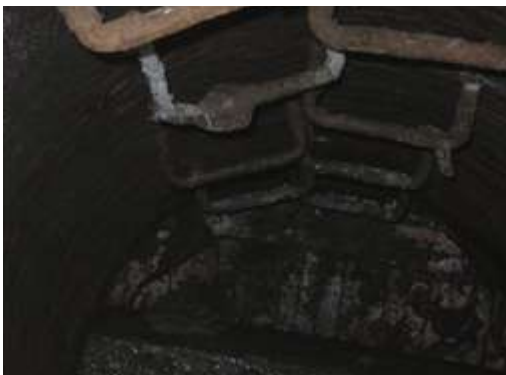
Defect 4

☒ **Evidence Of Surcharge** Depth: **4** (ft.) ☐ Active Surcharge Present

evidence of surcharge or dried concrete

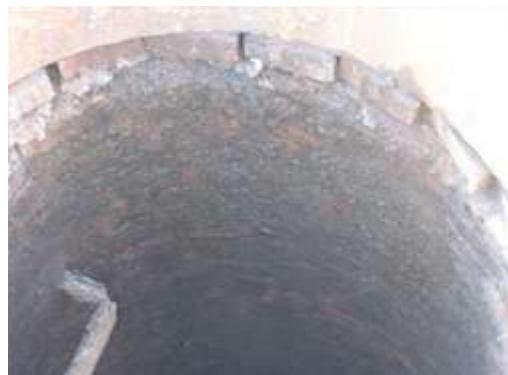
Defect 5

Infiltration: ☐ None ☐ Joint ☐ Cracks ☐ Mortar ☐ Roots ☒ **Wall**

infiltration along chimney wall

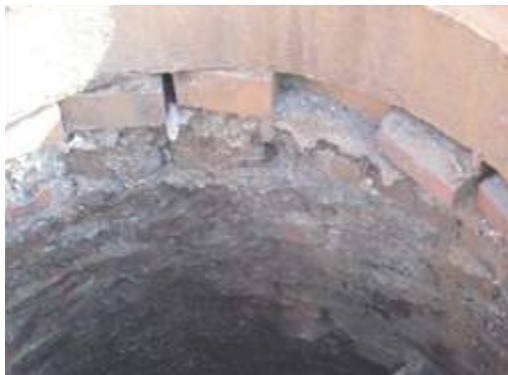
Defect 1

Condition: ☐ Sound ☐ Cracked ☐ Root Intrusion ☒ **Loose Brick** ☐ Deteriorated

loose bricks and mortar under frame

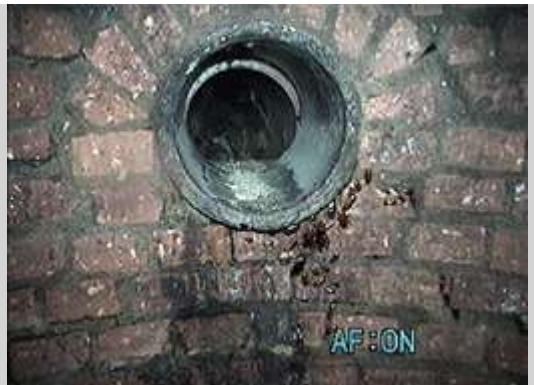
4 O'Clock Inflow

First section of pipe doesn't fully align with the second pipe
